Overview of the Second Quarter 2009 Surveillance and Maintenance Report for the LM Rocky Flats Site

Pond Operations – Second Quarter 2009

OLF Inspections

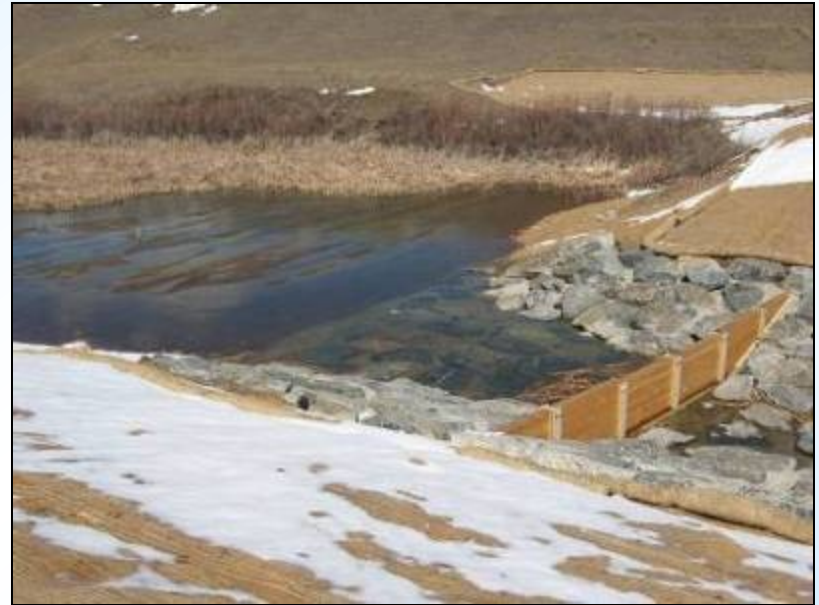
October 7, 2009,
Pond Levels

Landfill (21.3 percent)
A-3 (14.8 percent)
A-4 (32.8 percent)
B-5 (20.1 percent)
C-2 (12.1 percent)

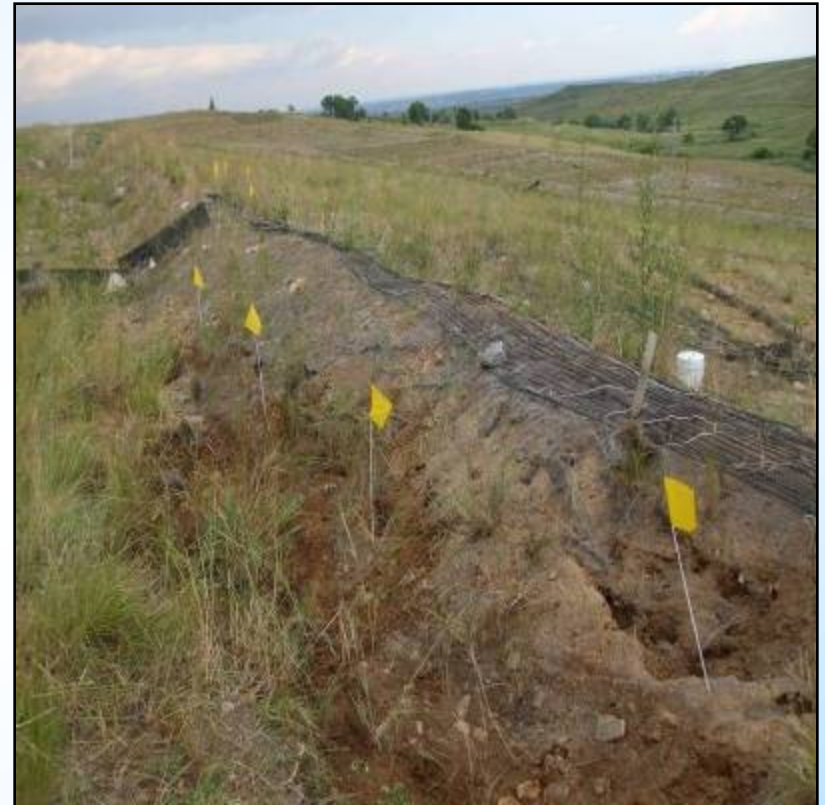
- Areas where the landfill cover is pushed up or rolling are noticeable on the western end of the OLF between Berms 2 and 3; however, the areas do not have any surface cracks at this time
- A new crack in Berm 1 was observed on April 4, 2009. The crack extended for a short distance through diversion Berm 1 to the north side of the berm and then back to the south side of the berm.
- These cracks were in the same general location of large cracks that appeared in 2006 and 2007
- Completed West Perimeter Channel regrading and channel drain in 2008 to improve stability. Slump not as severe as that noted in 2007.

- Continue maintenance actions to fill cracking to minimize infiltration of precipitation
- The main crack in Berm 1 was observed again on June 20, 2009
- Site staff again repaired the crack with hand tools and the ATV bucket
- Subsequent nonroutine inspections have shown no new movement in the area where the crack was repaired
